**PROPERTY CONDITION ASSESSMENT
OF
WORLD TRADE CENTER PORTFOLIO**

ONE WORLD TRADE CENTER

Merritt & Harris, Inc. Project Number 20-251E

Re: Due Diligence Physical Condition Survey
World Trade Center
New York, New York

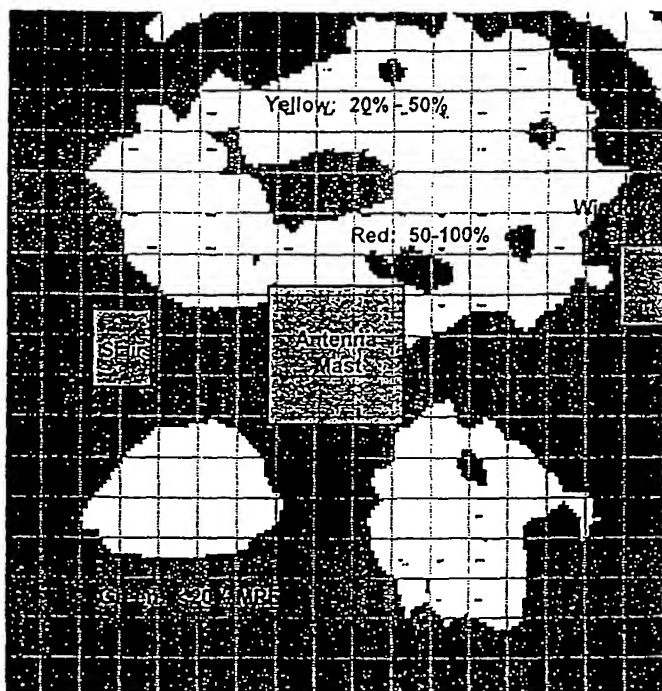
Figure 6. Roof map showing measured ambient RF fields on roof of north tower of World Trade Center during normal broadcast operations with contributions from 72 MHz paging links included. Maximum field is 70.2% MPE.

Statistical summary of RF Fields on WTC roof (see Figure 6)		
Percent occupational MPE range (%)	Roof area in this range (ft ²)	Percent of roof area in this range (%)
0-20	17070	62.75
21-50	9778	35.94
51-100	350	1.31
>100	0	0.00

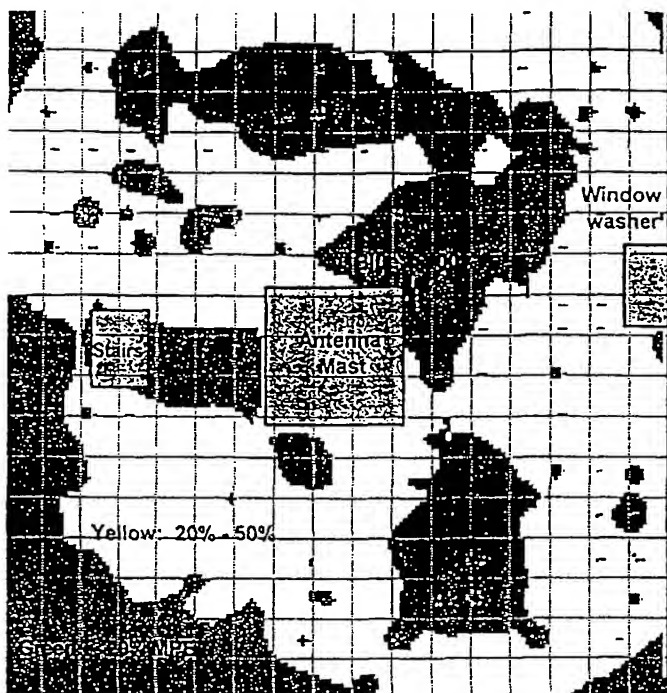
Figure 7. Roof map showing combined RF fields from measured ambient fields of normal broadcasting operations with calculated contribution of all wireless telecommunications antennas. Maximum field is 314 1% MPE

Statistical summary of RF Fields on WTC roof (see Figure 7)		
Percent occupational MPE range (%)	Roof area in this range (ft ²)	Percent of roof area in this range (%)
0-20	4502	16.55
21-50	16454	60.48
51-100	5963	21.92
>100	286	1.05

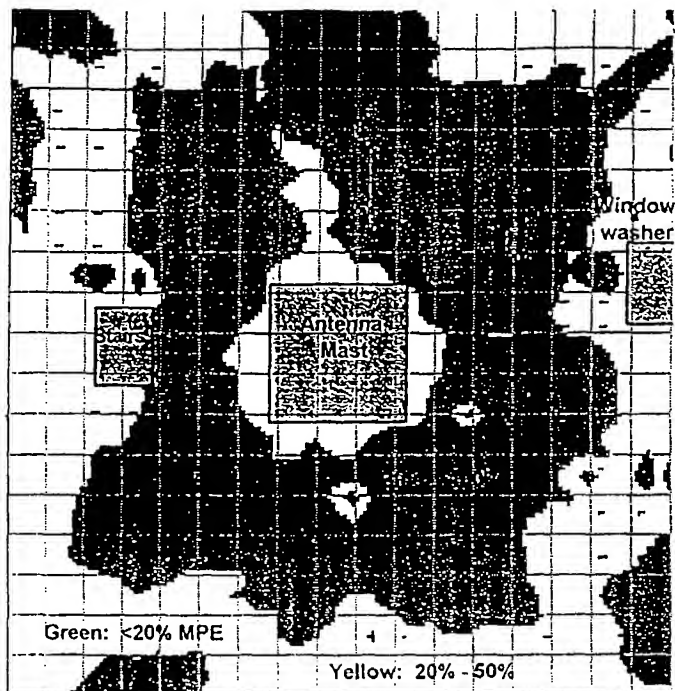
Figure 11. Roof map showing measured ambient RF fields on roof of north tower of World Trade Center during tower maintenance mode of broadcast operations with contributions from 72 MHz paging links included. Maximum field is 147.0% MPE.

Statistical summary of RF Fields on WTC roof (see Figure 11)		
Percent occupational MPE range (%)	Roof area in this range (ft ²)	Percent of roof area in this range (%)
0-20	1043	3.83
21-50	11728	43.11
51-100	13298	48.88
>100	1136	4.18

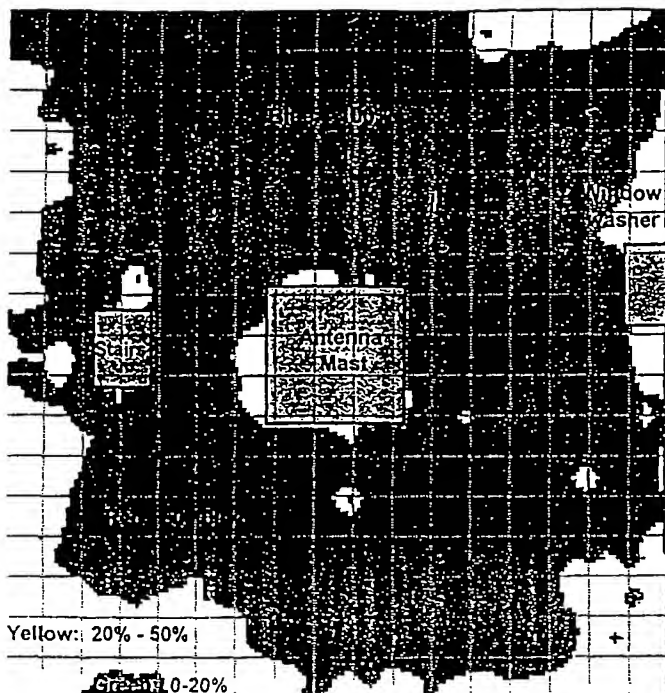
Figure 12. Roof map showing measured ambient RF fields on roof of north tower of World Trade Center during tower maintenance mode of broadcast operations with calculated contributions from all wireless telecommunications antennas included. Maximum field is 352% MPE.

Statistical summary of RF Fields on WTC roof (see Figure 12)		
Percent occupational MPE range (%)	Roof area in this range (ft ²)	Percent of roof area in this range (%)
0-20	130	0.48
21-50	5695	20.93
51-100	16891	62.09
>100	4489	16.50

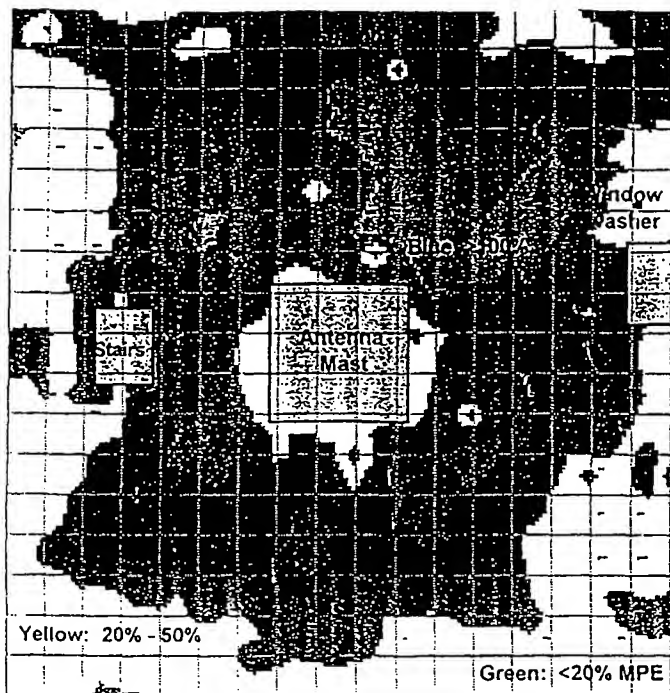
Figure 15. Roof map showing measured ambient RF fields on roof of north tower of World Trade Center during emergency backup broadcast operations with contributions from 72 MHz paging links included. Maximum field is 156.3% MPE.

Statistical summary of RF Fields on WTC roof (see Figure 15)		
Percent occupational MPE range (%)	Roof area in this range (ft ²)	Percent of roof area in this range (%)
0-20	253	0.93
21-50	8677	31.89
51-100	15694	57.69
>100	2581	9.49

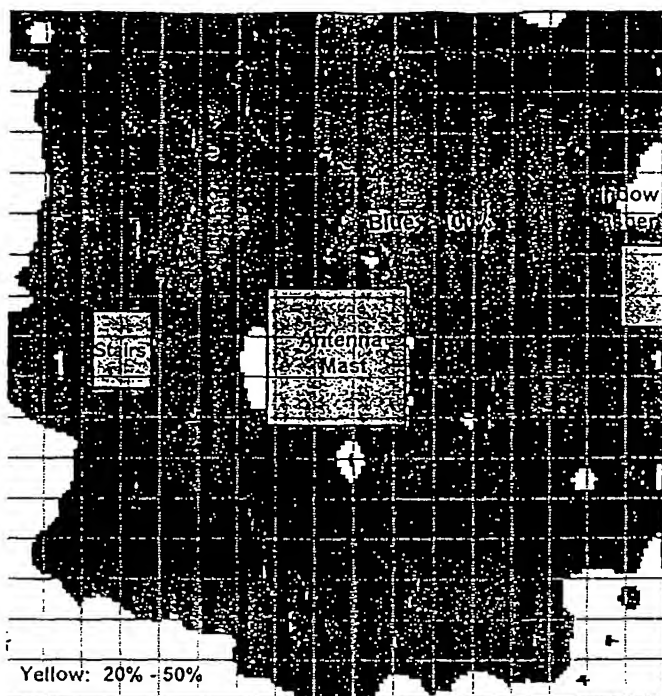
Figure 16. Roof map showing measured ambient RF fields on roof of north tower of World Trade Center during emergency backup broadcast operations with calculated maximum contributions from all wireless telecommunications antennas. Maximum field is 373.0% MPE.

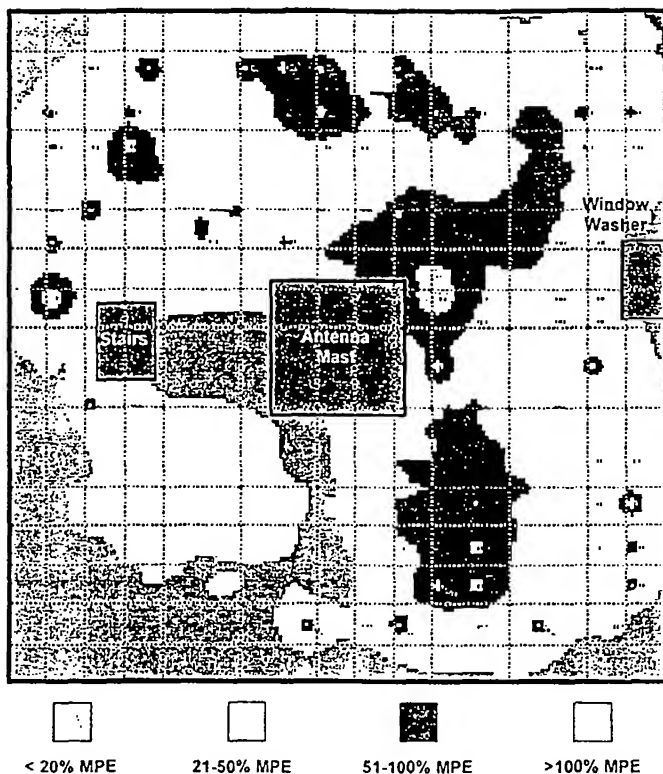
Figure 1. 1999 reevaluation of RF fields from measured ambient fields of normal broadcasting operations with calculated contribution of all wireless telecommunications antennas. Maximum field is 299.6% MPE.

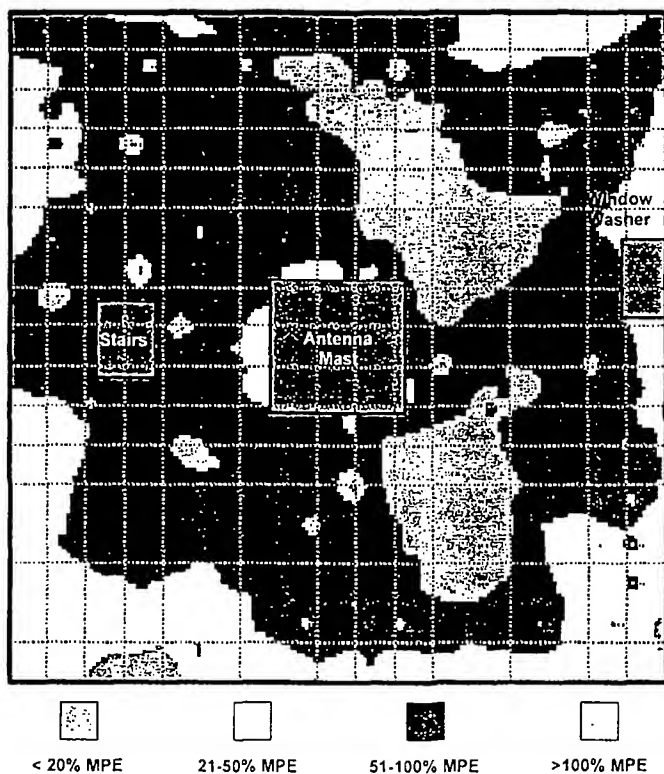
Figure 3. 1999 reanalysis of RF fields from measured ambient fields of tower maintenance broadcasting operations with calculated contribution of all wireless telecommunications antennas. Maximum field is 333.5% MPE.

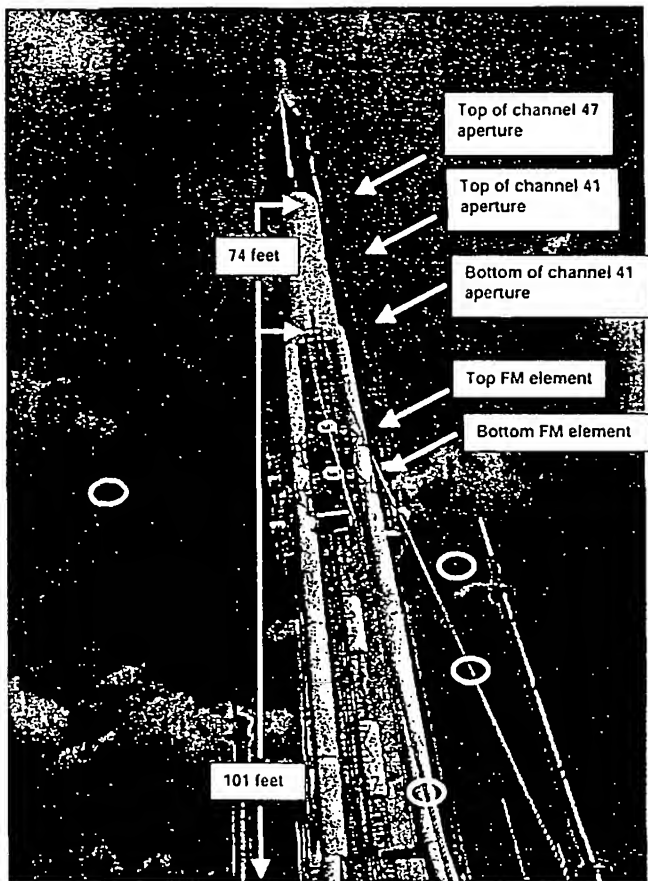
Figure 3. View of the antenna mast on the World Trade Center north tower showing ropes rigged to ice shield at top of the channel 47 antenna aperture. During measurements, the bottom ends of the ropes were brought from their temporary anchor points near the edge of the roof to the base of the mast and rigged over pulleys to facilitate up and down movement of the electric field strength probe. The principal working area that will be used during the antenna work is shown. The lower dimension is relative to the TV mast interface on the roof. Ropes are highlighted with ovals around them.

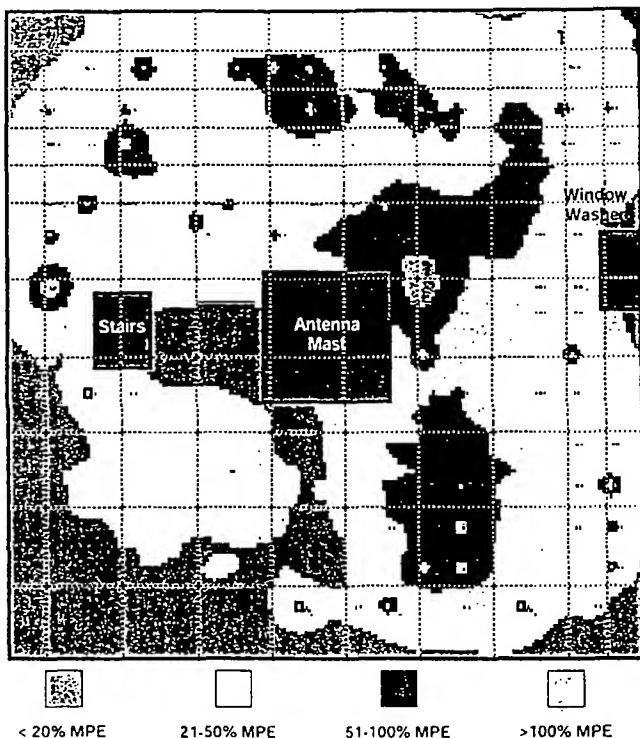
A 1999 reevaluation of RF fields from measured ambient fields of normal broadcasting operations with calculated contribution of all wireless telecommunications antennas (see footnote on page 10). Maximum field is 299.6% MPE.
